## Sanitary Sewer Overflow or Bypass Notification Summary Report

# Bloomington and Normal Water Reclamation District

RE: Sanitary Sewer Overflow or Bypass Notification Summary Report

The Bloomington and Normal Water Reclamation (BNWRD) is providing the following information to fully explain and document the Sanitary Sewer Overflow (SSO) event that occurred on June 26, 2021 at the Southeast WWTP. The discharge was reported to the Agency's Jeff Holste via telephone call on Saturday June 26<sup>th</sup> 2021 shortly before 2:30pm.

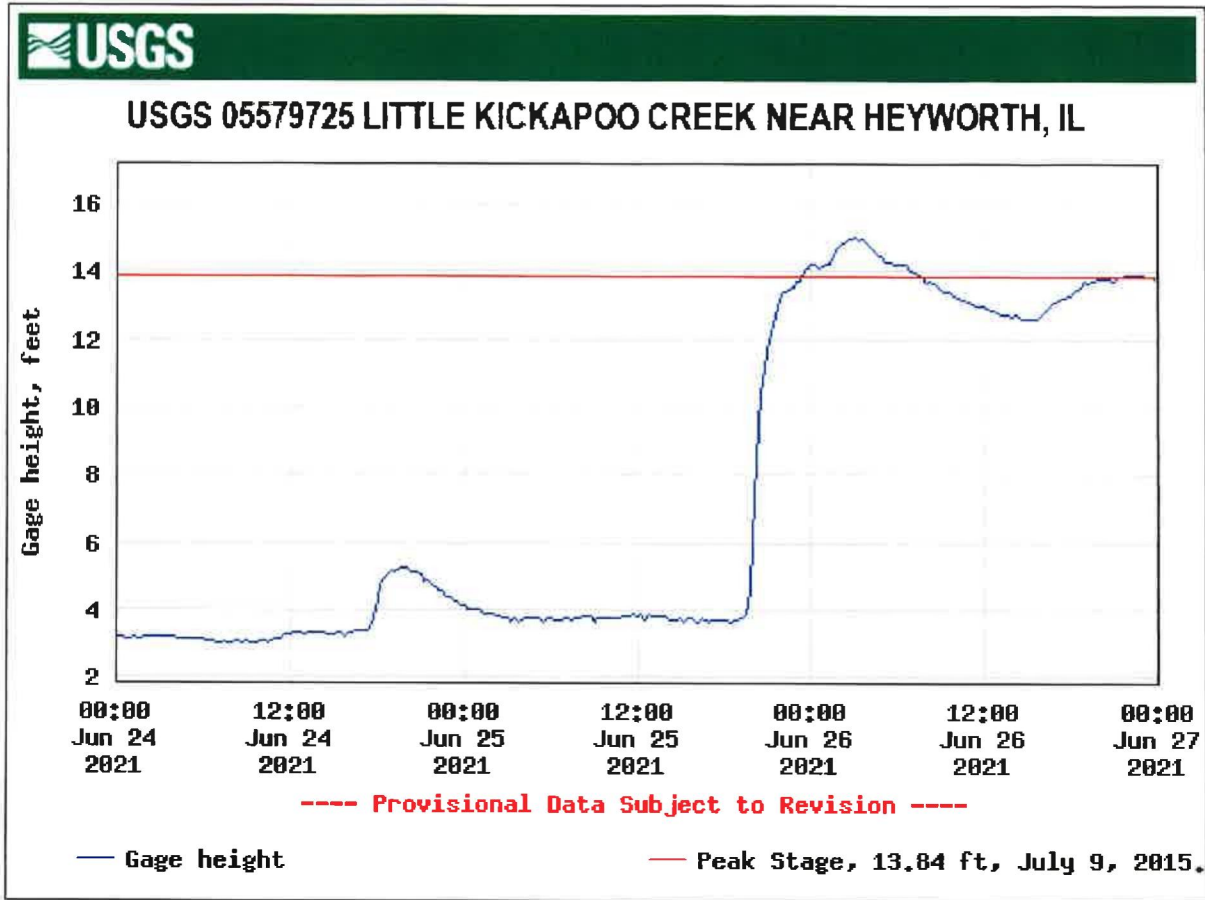
Figure 1

ESI runs parallel to Little Kickapoo Creek upstream from Southeast WWTP. Staff observed Little Kickapoo Creek was entirely out of its banks. USGS Stream Gauge monitoring data indicates the unprecedented flow surge (Figure 1).

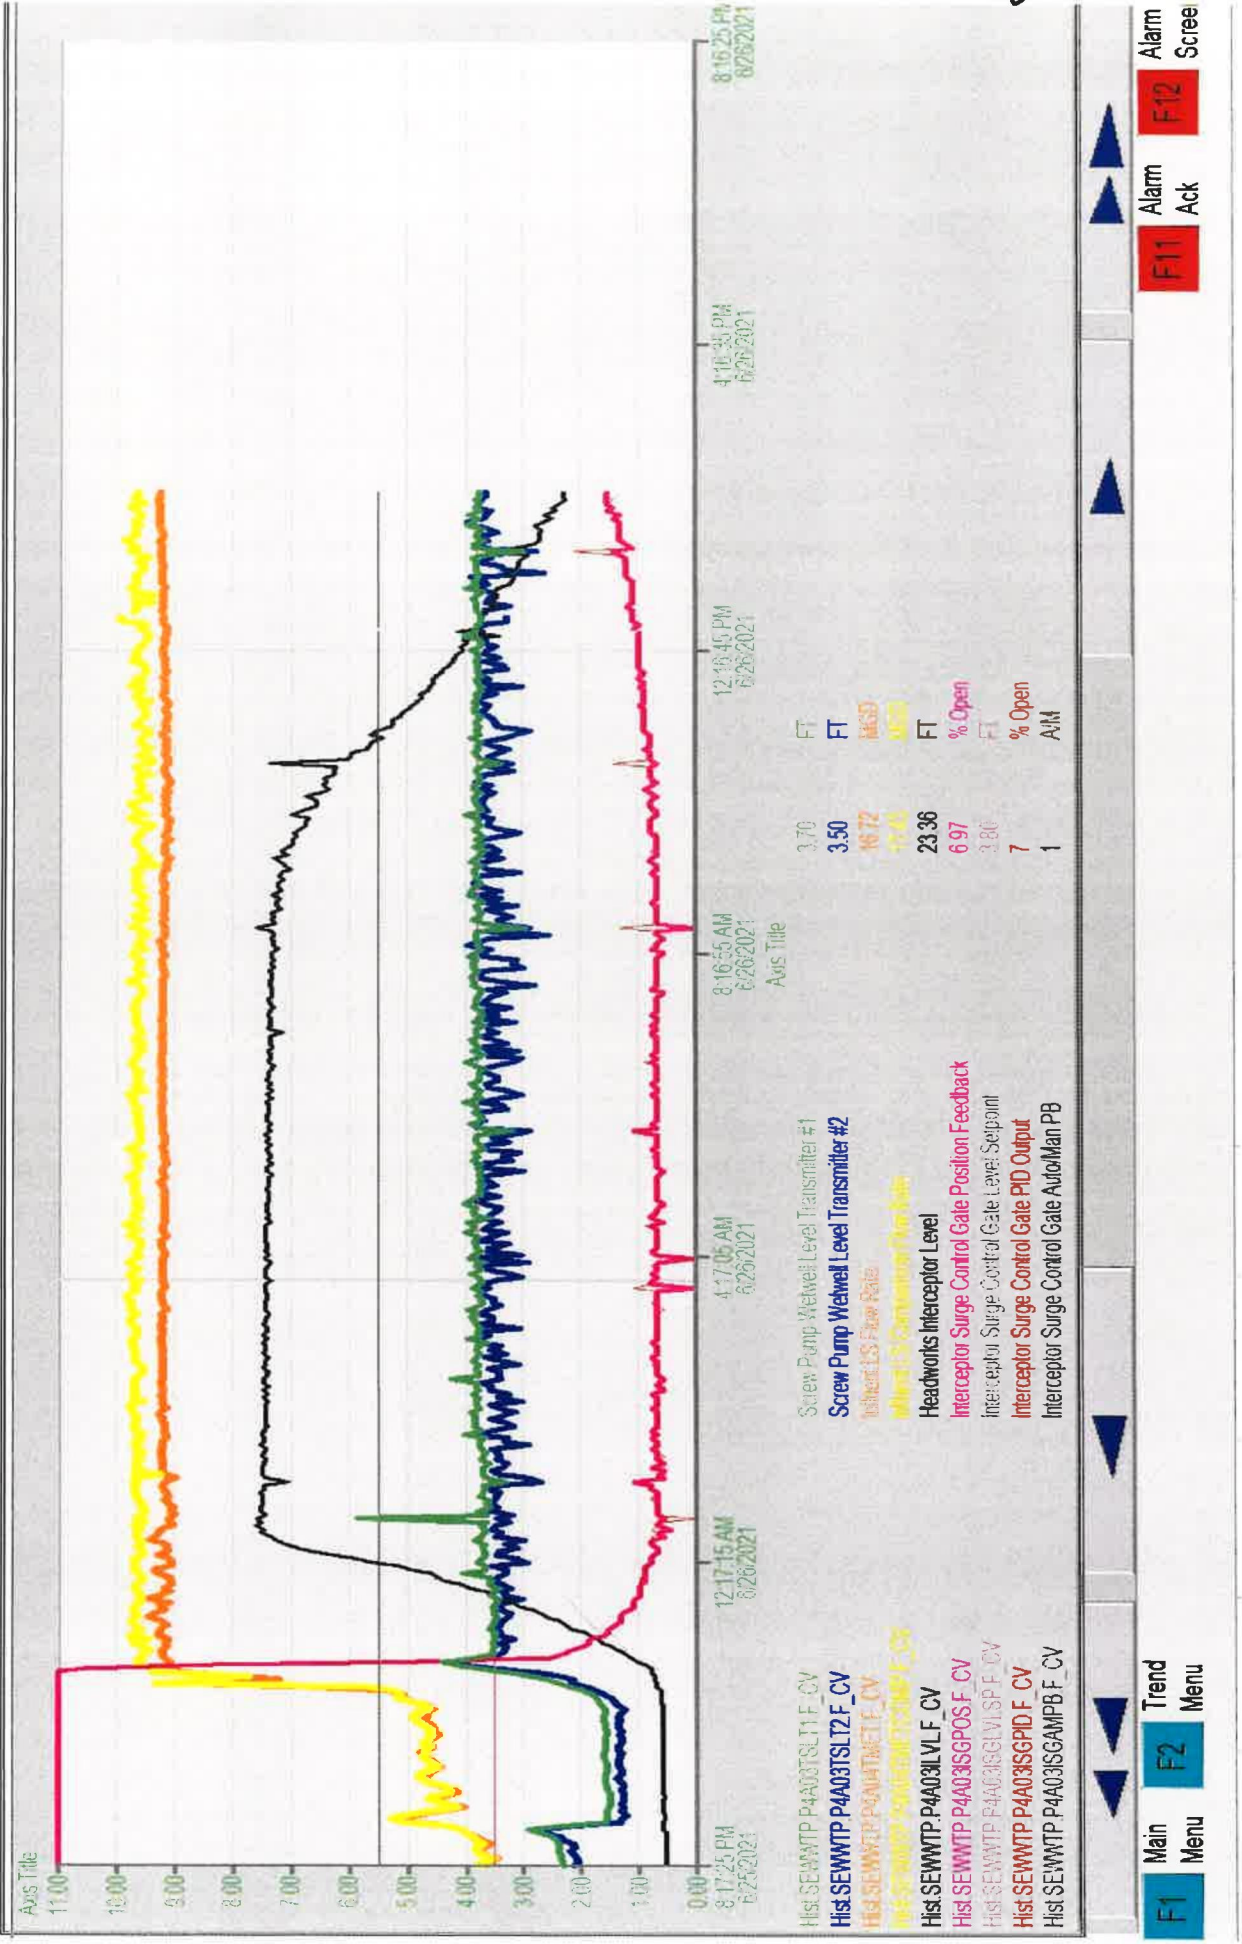
Figure 2

Influent flows to the Southeast WWTP were at or slightly above design maximum flow of 16.9MGD prior to and during the SSO event. SCADA trending for the Southeast WWTP indicates the surge control gate functioned as designed, the treatment plant was at maximum design capacity, and shows the rapid spike in level at the level sensor monitoring manhole (Figure 2).
